Manhole Inspection Summary

Manhole # **S39GG_024MH**

Insp Date: **1/15/08 1:43 PM**

Location Address: **1415 TOWNWAY**

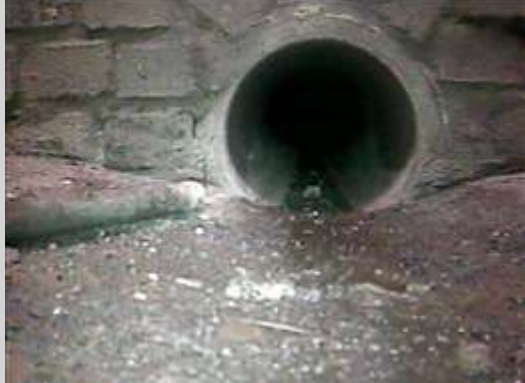
12 O'Clock Outflow

8 in. Circular Gravity Sewer
Pipe Out @ 12 O'Clock

Pipe Material: **Clay** ☐ Pipe Lined

Invert Depth: **8.50** (ft.) Flow Characteristics: **None**

Deposits: ☒ None ☐ Mud ☐ Sludge ☐ Debris ☐ Grease

Infiltration: **None** Pipe Seal Cond: **Sound**
